Manhole Inspection Summary

Manhole # S11Q__010MH

Insp Date: **4/17/08 12:40 PM**

Location Address: **3207 Strickland Ave**

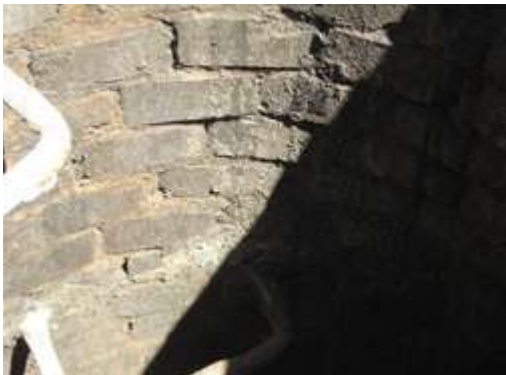
Defect 5

Corbel Material: **Brick** ☐ Parged Type: **Concentric/Eccentric**

Condition: ☐ Sound ☒ **Cracked** ☐ Root Intrusion ☐ Loose Brick ☒ **Deteriorated**

corbel cracked and deteriorated

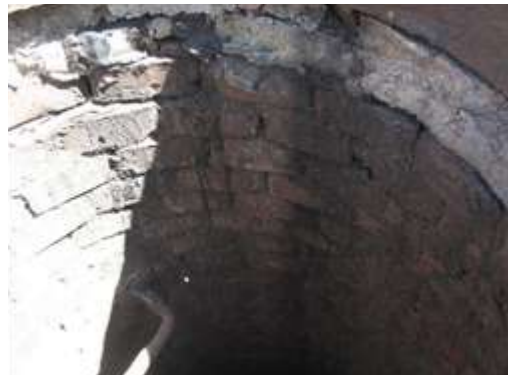
Defect 4

Chimney / Frame Adjustment ☒ Exists Material: **Brick and Concrete** ☐ Parged Height: **4** (in.)

Condition: ☐ Sound ☒ **Cracked** ☐ Root Intrusion ☐ Loose Brick ☒ **Deteriorated**

chimney cracked and deteriorated

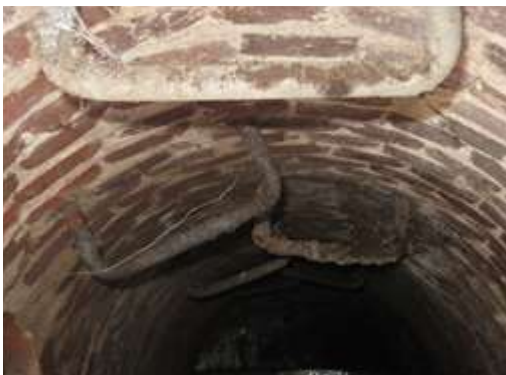
Defect 2

Steps Count: **5** Missing: **0** ☒ **Corroded**

steps corroded

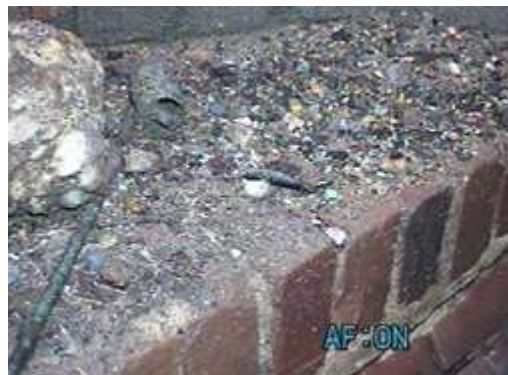
Defect 1

Condition: ☐ Sound ☐ Cracked ☐ Root Intrusion ☐ Deteriorated ☐ Leaks ☒ **Debris**

bench debris

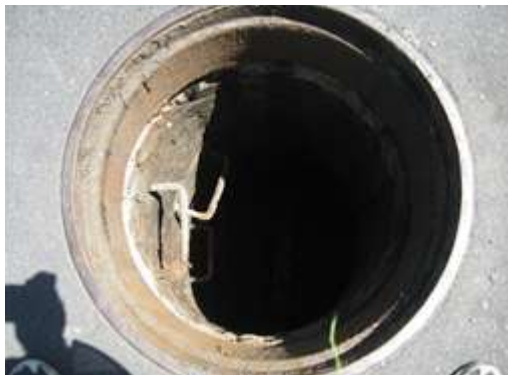
Defect 3

Frame Offset: **0** (in.) Condition: ☐ Sound ☐ Cracked ☒ **Leaks**

frame leaks at cover

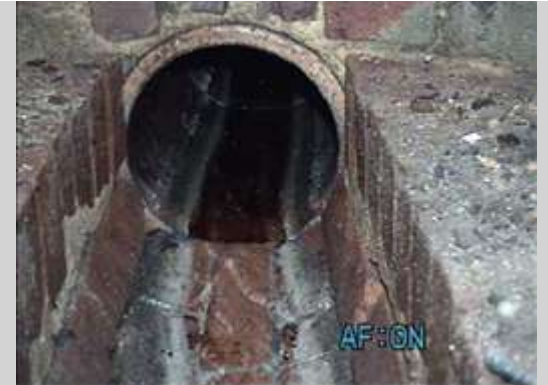
12 O'Clock Outflow

8 in. Circular Gravity Sewer
Pipe Out @ 12 O'Clock

Pipe Height: **8.4** (in.) Rod and Bar (Angled)
Pipe Material: **Clay** ☐ Pipe Lined
Invert Depth: **9.35** (ft.) Flow Characteristics: **Fast**
Deposits: ☒ None ☐ Mud ☐ Sludge ☐ Debris ☐ Grease
Silt Depth: **0** (in.) Deposits Extent:
Infiltration: **None** Pipe Seal Cond: **Sound**

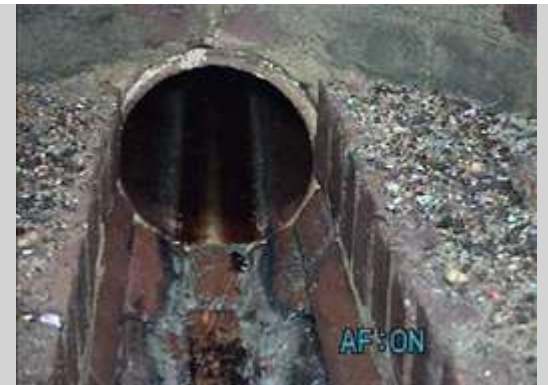
6 O'Clock Inflow

8 in. Circular Gravity Sewer
Pipe In @ 6 O'Clock

Pipe Height: **8.4** (in.) Rod and Bar (Angled)
Pipe Material: **Clay** ☐ Pipe Lined
Invert Depth: **9.95** (ft.) Flow Characteristics: **Fast**
Deposits: ☒ None ☐ Mud ☐ Sludge ☐ Debris ☐ Grease
Silt Depth: **0** (in.) Deposits Extent:
Infiltration: **None** Pipe Seal Cond: **Sound**
